APS

Troubleshooting Guide

SOP-ED-09 A/0

ALTENERGY POWER SYSTEM INC.

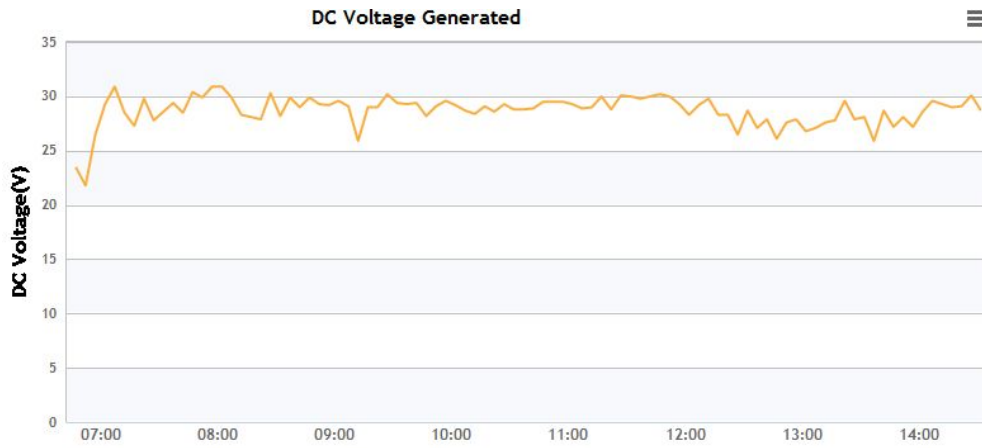
1) V_{dc} is around 30V while V_{ac} is abnormal. This indicates the inverter is disconnected from the grid. Alternatively, loose AC plug connection between inverters might be the cause, see the troubleshooting below:

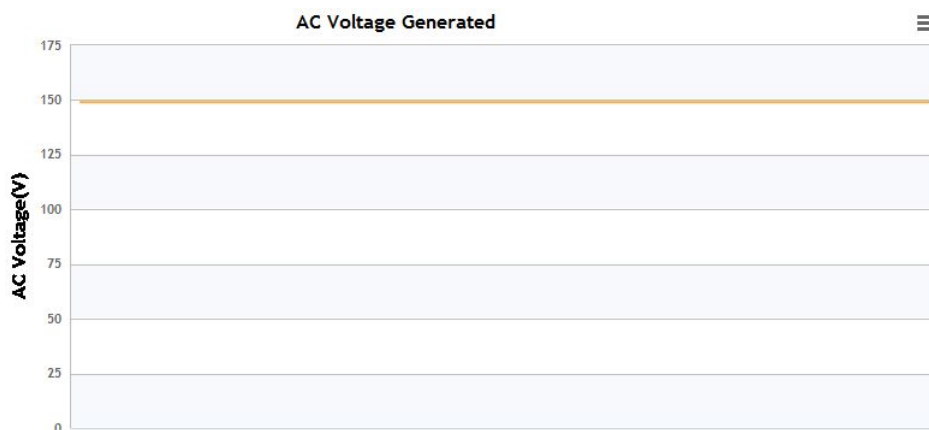
Check AC Measurement in EMA of these units and Vac should be always abnormal like the screenshot below. This indicates that the string is disconnected from the grid. Check that Solar circuit breakers and Isolators in “ON” position.
